Manhole Inspection Summary

Manhole # S29GG2024MH

Location Address: **100 BELLEMORE RD**

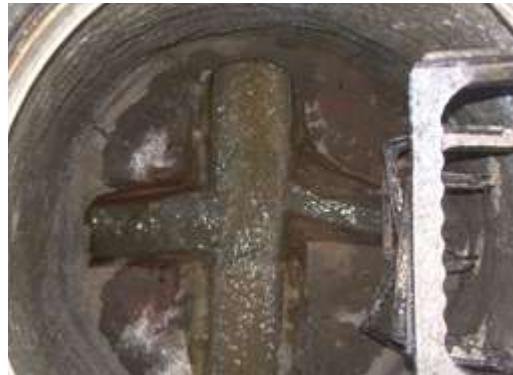
Top View

Bench debris.

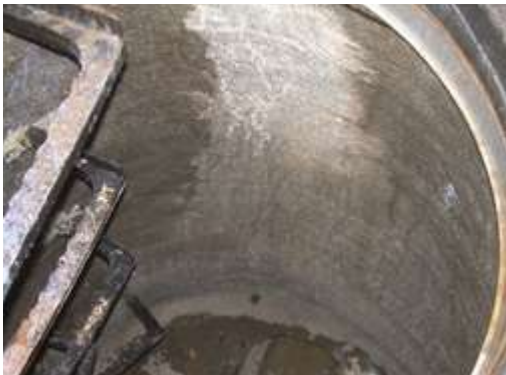
Defect

Adjustment and Barrel infiltration - other side.

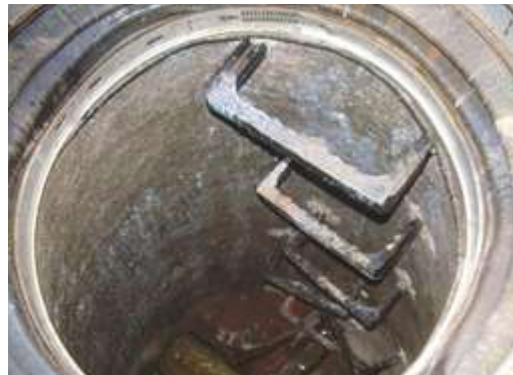
Defect

Adjustment and Barrel infiltration.

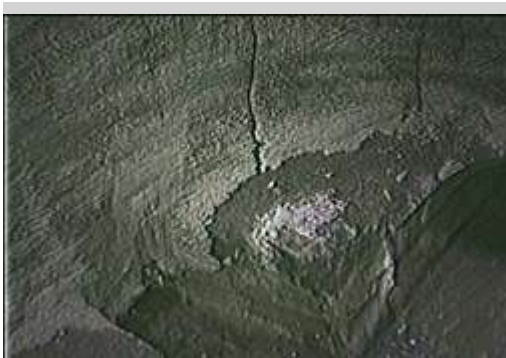
Defect

Condition: ☐ Sound ☒ **Cracked** ☐ Root Intrusion ☐ Loose Brick ☐ Deteriorated

Infiltration: ☐ None ☐ Joint ☒ **Cracks** ☐ Mortar ☐ Roots ☒ **Wall**

Barrel cracks.

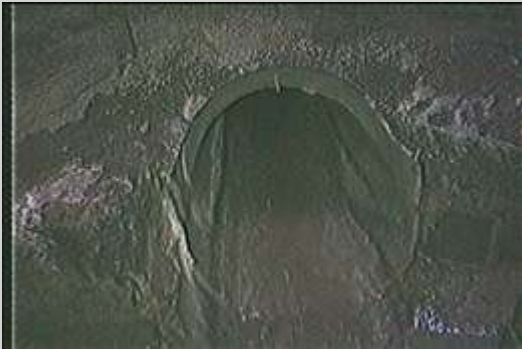
15 in. Circular Gravity Sewer Pipe Out @ 12 O'Clock

Infiltration: **Evidence** Pipe Seal Cond: **Unknown**

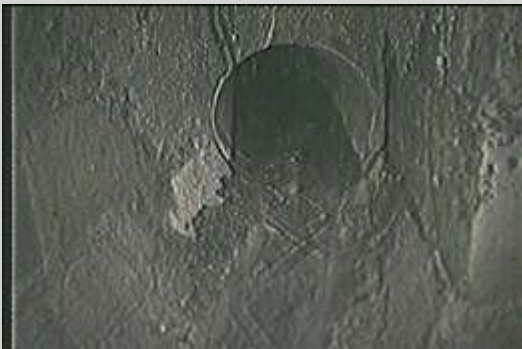
8 in. Circular Gravity Sewer Pipe In @ 3 O'Clock

Infiltration: **Evidence** Pipe Seal Cond: **Unknown**

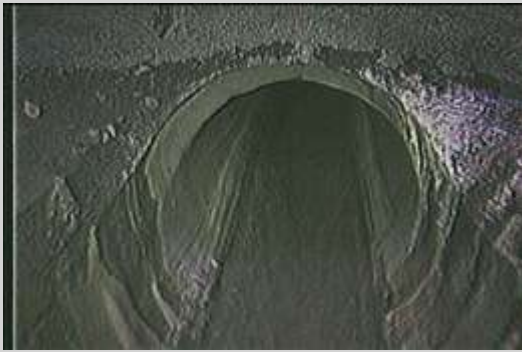
Pipe In @ 6 O'Clock

Infiltration: **Evidence**

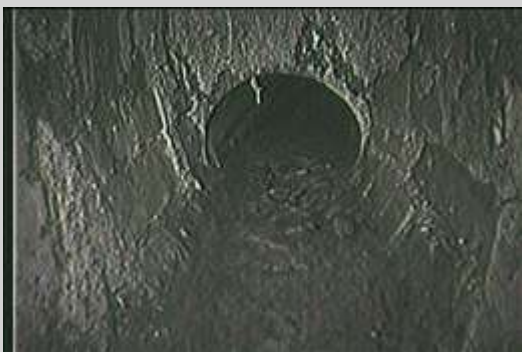
Pipe In @ 9 O'Clock

Deposits: ☐ None ☒ **Mud** ☐ Sludge ☒ **Debris** ☐ Grease

Silt Depth: **0.5** (in.) Deposits Extent: **Light**

Infiltration: **Evidence**
